BEVERLY MIDDLE SCHOOL

EXISTING CONDITIONS

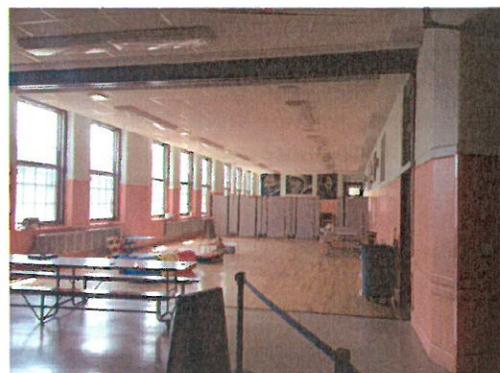
The Cafeteria is a long, narrow room located on the main level on the backside of the building with little acoustic treatment. This was a common approach 90 years ago, when the Cafeteria was viewed as a loud space where students were "herded" in and out as quickly as possible for daily meals. Today, student dining areas serve a much more comprehensive educational and social purpose, and are often made an integral and central part of dining, presentations, performances, parent and volunteer activities, social events, and numerous other school and Town activities. These spaces require an appropriate location, natural day-lighting,

view of existing Cafeteria

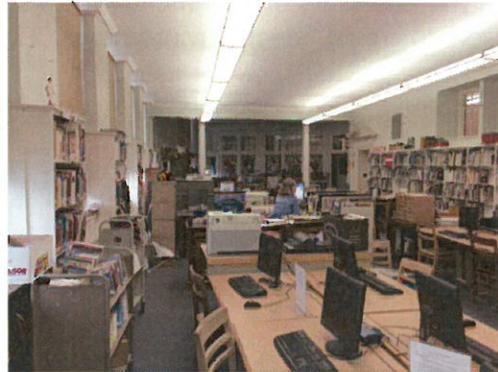
The Library Media Center is located on the second floor, centrally located within the academic classrooms on that floor. This was also a popular approach 90 years ago, but today's Library Media Center seeks an even more central and convenient location for use by students, educators, parents, and the general public. Ninety years ago, the "Library" included several thousand volumes of hardcopy books and a card catalogue reference system. Today, it is a technology driven, data based, media retrieval center that promotes inquiry and research by teachers, students, parents, and the general public, with no limitations on subject matter or breadth of information. It is also a media and data distribution center where students create, direct, and broadcast information, presentations, and performances. In addition to being poorly located and lacking all modern amenities, the existing library is a quarter of the required program size of a modern middle school library.

view of existing Library Media Center

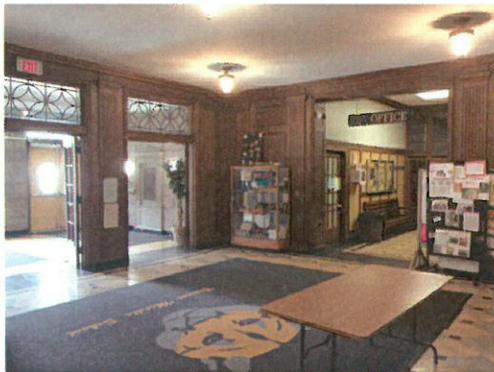
The building's Administration area is centrally located within the academic wing on the main floor level, but its location away from the main entry doors does not provide the required observation and control of visitors entering the building. This was common 90 years ago, when school security was not an issue. Unfortunately, this has changed dramatically over the past ten years. Currently, the main office relies on a camera system for visual observation of the main entrance. This is a commendable effort considering the building's organizational challenges, but unfortunately potential security and safety hazards remain. Upon entering the building, visitors pass through a portion of the building's main circulation corridor to enter the Administrative office and have the potential to intermingle with staff and students prior to being greeted and checked in by the Main Office.

view of existing entry organization

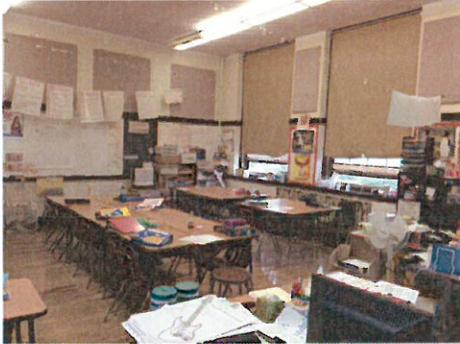
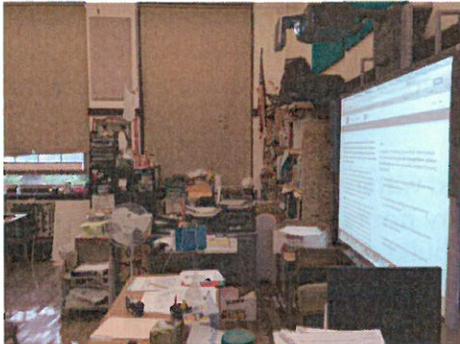
views of existing classroom

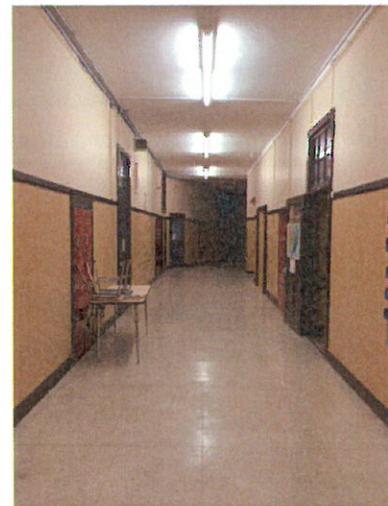
view of existing corridor

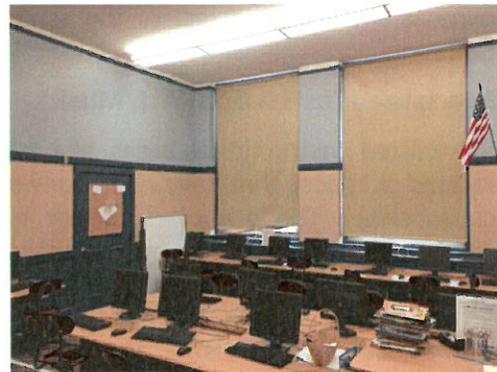
The Computer Lab is located on the second floor. This space is a converted classroom that does not have adequate cooling and is insufficiently sized. Equipment and devices within the lab are outdated.

view of existing computer lab

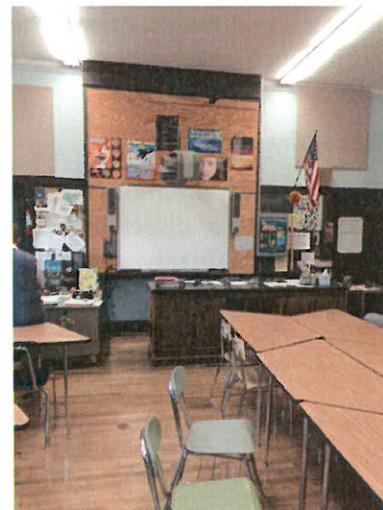
The existing Beverly Middle School does not have an adequate quantity of classroom spaces. The current instructional classrooms are all significantly undersized compared to current educational space standards. In an attempt to address the lack of classroom space, "larger" classrooms (larger, meaning, as compared to the typical classroom size of approximately 650 square feet) have been broken into two smaller, undersized classrooms. A portion of the Cafeteria was broken up and converted into a classroom space. This classroom space opens directly into the Cafeteria and during the lunch periods presents a significant acoustical distraction.

view of existing classroom

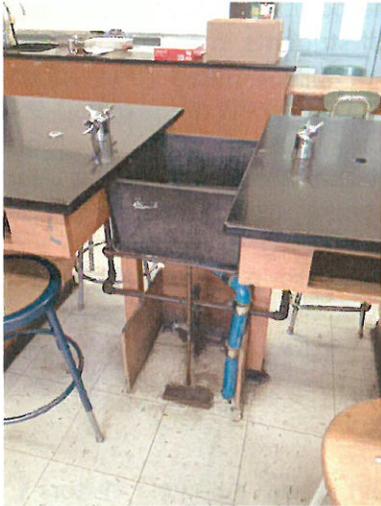
view of science classroom

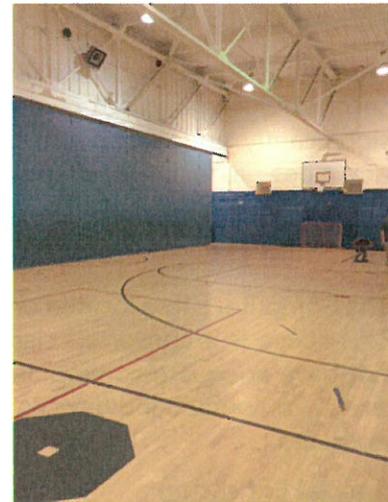
The overall space of the Gymnasium is undersized in comparison to current state recommendations and guidelines. Access to the gymnasium from the rest of the school is through the Cafeteria.

view of existing Gymnasium

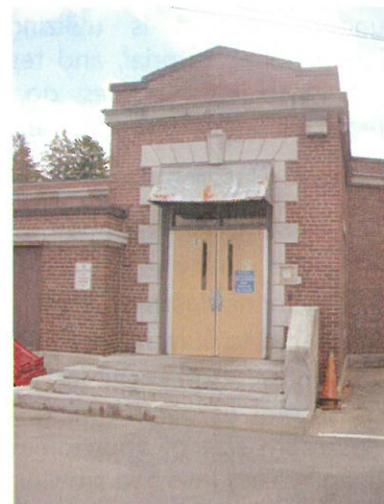
The receiving area for the school is serviced by a double door with no direct access to grade, making regular deliveries difficult. Storage space in the school is extremely limited.

view of existing receiving area

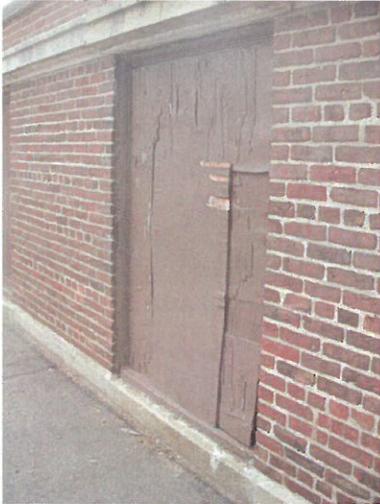
view of rotting window infills

Window openings on the rear of the building have been infilled with painted plywood panels. Wood rot and cracking is visible.

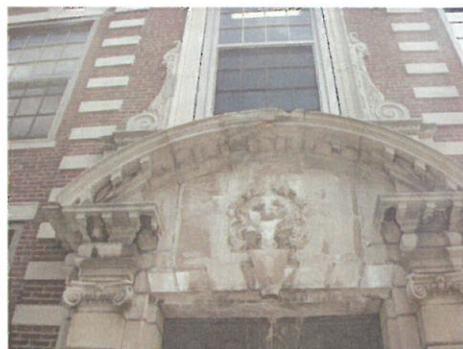
The exterior detailing of the building including the precast cornices, door surrounds, sills and headers have significant deterioration and require replacement and / or restoration in many locations.

view of deteriorating exterior detailing

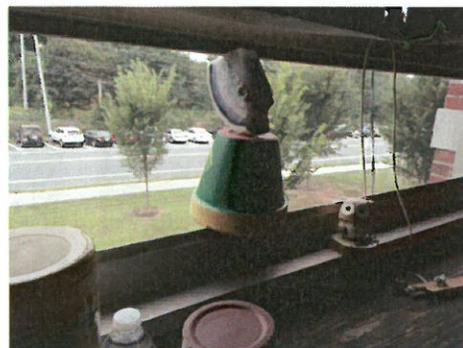
In 1995, the exterior windows of the building were replaced with a double pane aluminum window system. On the surface, the window systems appear to be in fair condition, but looking into them with greater detail, the years of exposure are apparent. A majority of the windows are inoperable due to failed spring balances. In 2009, spring balances were repaired/replaced in select window openings to allow at least one window in each classroom

view of window being held open due to inoperable balances

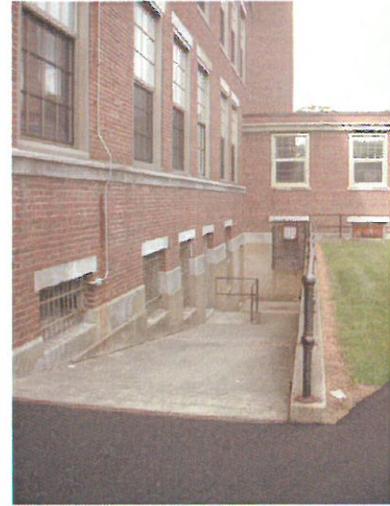
There are a couple below grade doors that sit in wells. There is a potential for flooding of the wells and subsequent water infiltration at the doors during heavy rain events.

view of exterior door well

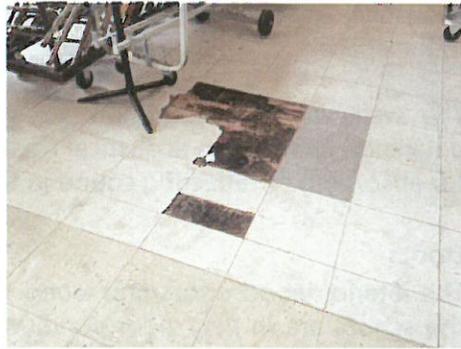
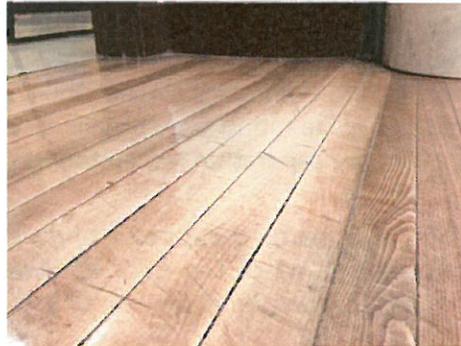
The corridor and classroom floors are primarily VAT and VCT. Various locations have been patched with VCT. Select classrooms floors are hardwood. The floors in the corridor are in good condition and maintained. The floors in the classrooms are in poor condition and are damaged in numerous locations. The floor on the lower level is painted concrete and shows significant wear.

The wood flooring in the Gymnasium visually appears to be in fair condition, but closer examination reveals there are numerous "dead spots" in the floor, buckling, and signs of wear. The flooring system has exceeded its life expectancy.

examples of flooring

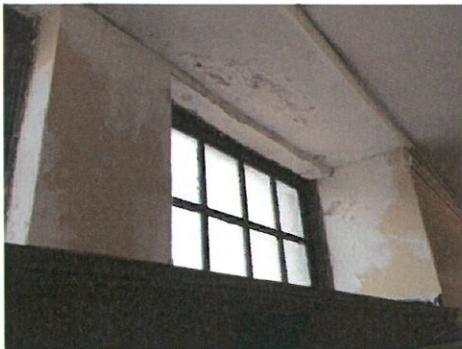
The majority of the walls within the classrooms are painted plaster with a wood chair rail and wood base. The age of the walls is apparent as modern retrofitted amenities are all exposed including wiring for power, light switches, technology, and interactive whiteboards. Many of the walls are damaged and in disrepair due to moisture damage from leaking windows and roof. Paint is also peeling from the wall due to the moisture damage.

example of moisture damage

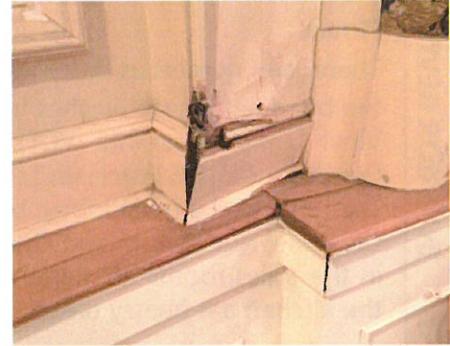
The walls in the Auditorium are plaster with wood detailing. There is no acoustical treatment on the walls for absorbing or reflecting sound in the space.

damaged wood detailing

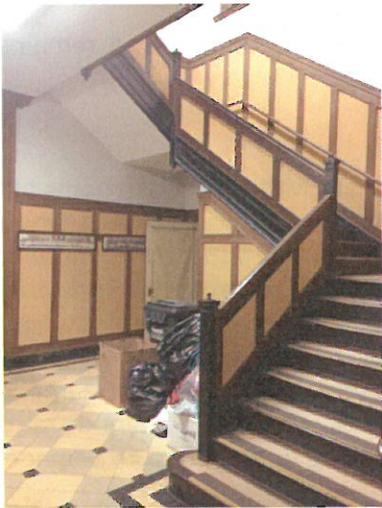
non-code compliant guardrail and handrails at stairs

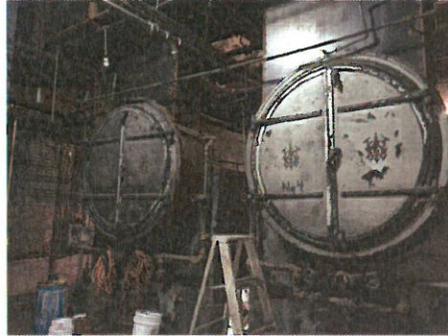
- Each boiler has a capacity of 150 Boiler Horsepower (BHP).
- Each boiler has been retrofitted with an Industrial Combustion burner firing on natural gas. The boilers were originally designed for oil but have now been converted to natural gas only.
- These boilers have been in continuous service since 1955, have been re-tubed multiple times and now suffer tube sheet stress issues as a result, which will prevent future re-tubing.
- Both boilers are required to fire on cold, near design days, which leaves no back-up or redundancy should a boiler failure occur.
- The Burnham boilers have far outlived their useful service life.
