GAR Hall
Beverly, MA

**Building Assessment,
Preservation and Reuse Plan**

GAR Hall
Building Assessment, Preservation Plan and Reuse Plan Study
15 January 2017

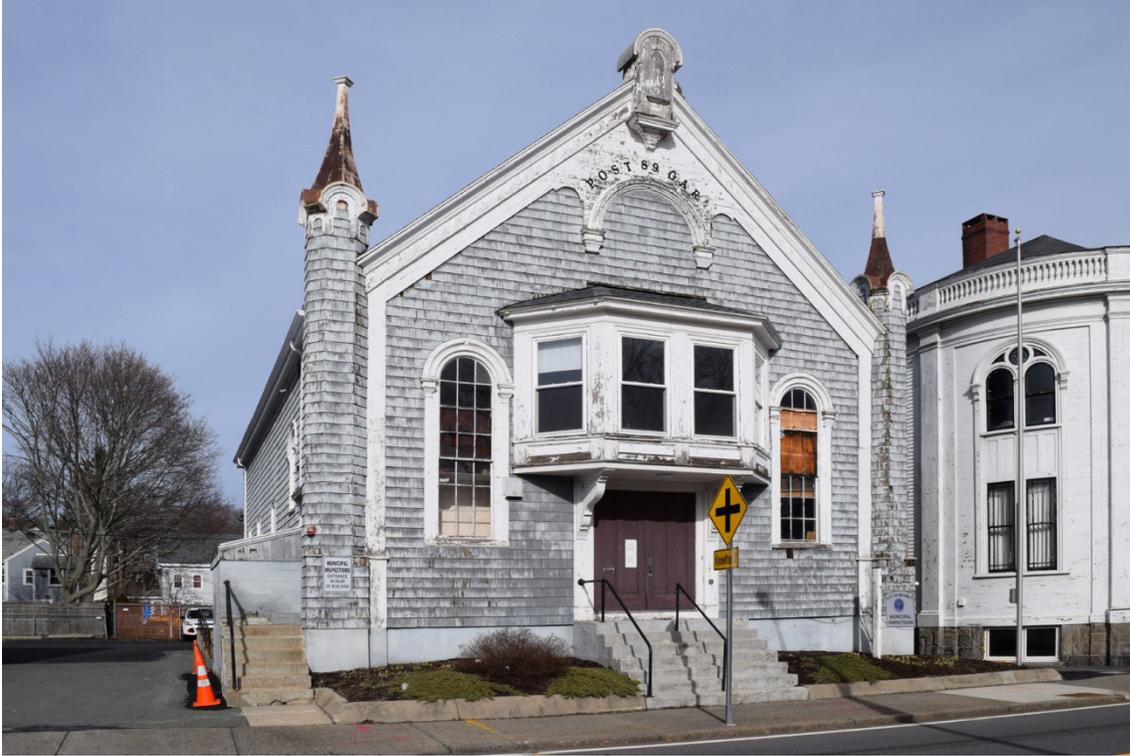
- The shingle siding is rather rustic in the context of the Romanesque character of the original design. It is also deteriorating, especially on the front façade, which exacerbates the contrast.

Front façade

1. Removal of the present wood shingles and examining the substrate, making repairs where required.
2. The 1905 siding was wood clapboards applied over the original flush wood siding. This should be reconstructed, with a water table at the base as can be seen in the historic photograph.

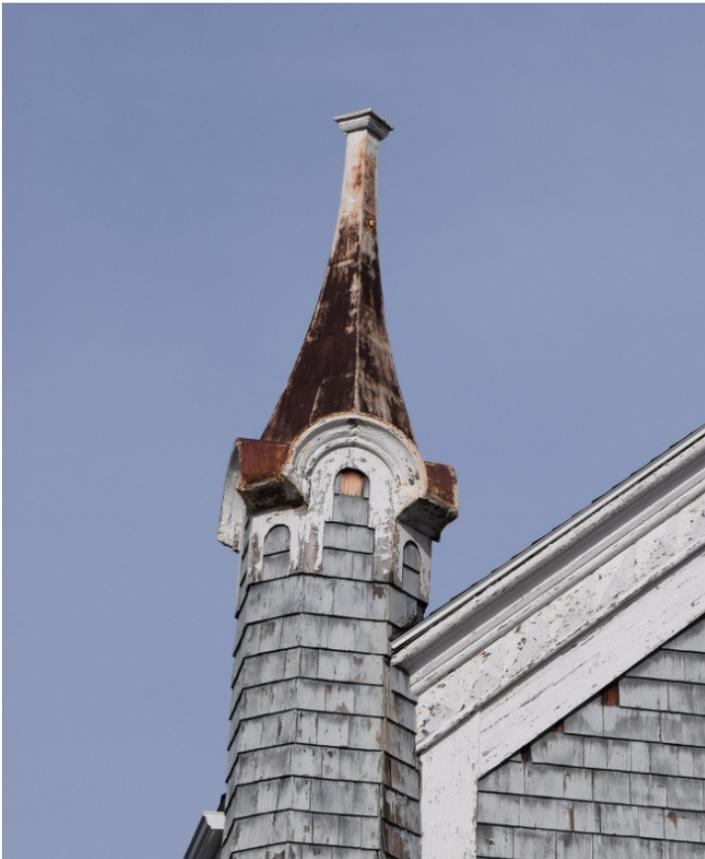
- Metalwork on the finials and acroterion need repair work. They appear to have been galvanized sheet metal and were probably painted. Today they are rusted and probably leaking.

Detail of spire

9. Replacement of the decorative metal roofing and flashing at the spires and the central acroterion.
10. Reconstruction of the acroterion, based on remaining physical evidence and the historic photograph.

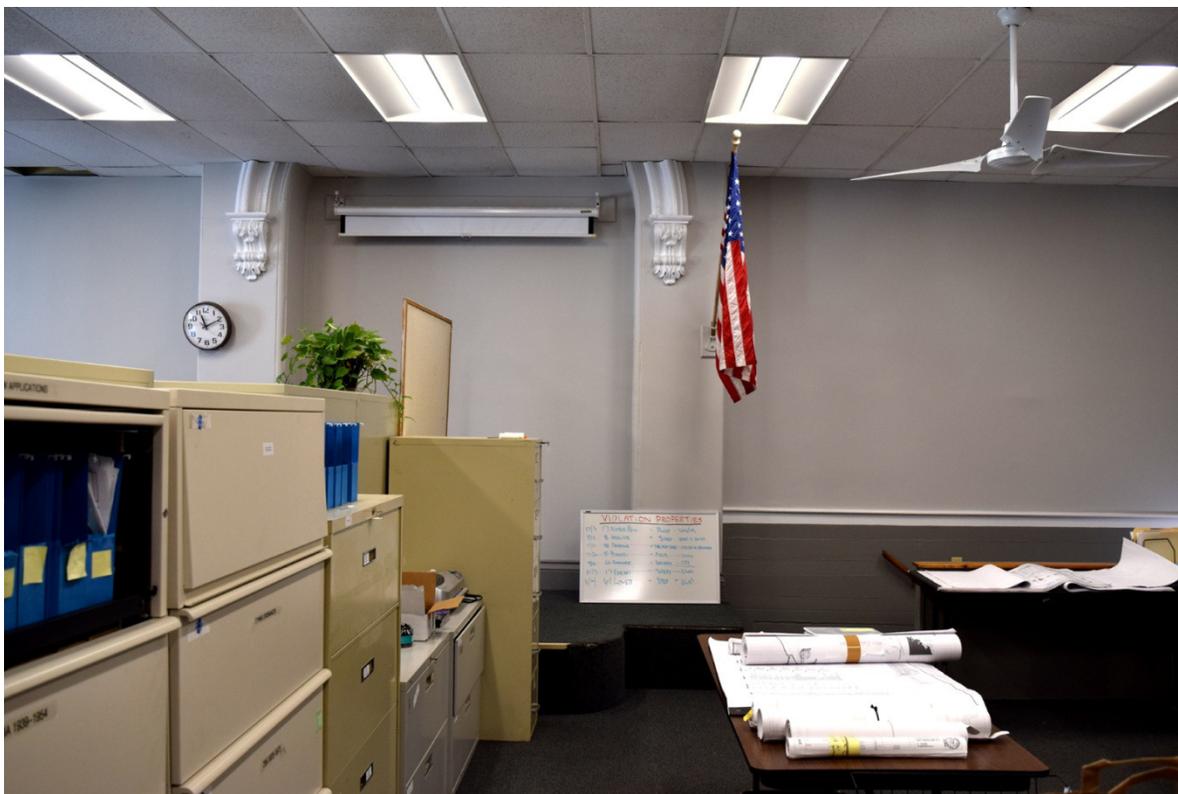
First floor- moldings above platform were cut for acoustic tile ceiling

Interior restoration scope is primarily part of the first floor work. Design should include planning to reuse existing spaces and leave historic details in place. Restoration or replacement of key details will be required at some locations. Interior details at new windows in the main space should use the detail of the window in the stair to the mezzanine as a model, and new doors and casings at toilet rooms should be based on the historic doors. In the main space, the wood wainscot should be retained, and field work should be done to verify the profile of the chair rail. The wall and ceiling plaster would be restored, and the arch at the platform should have its moldings restored where they were cut for the acoustic tile ceiling.

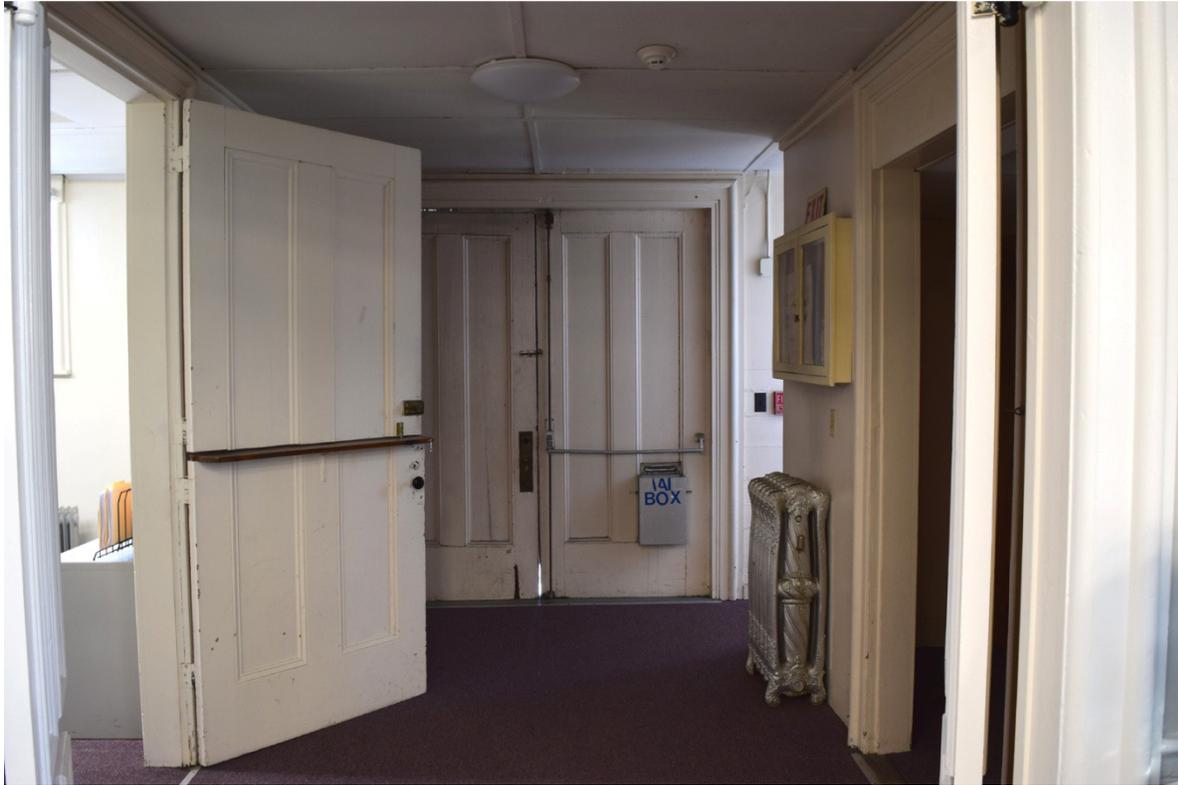
First floor vestibule and original entrance doors

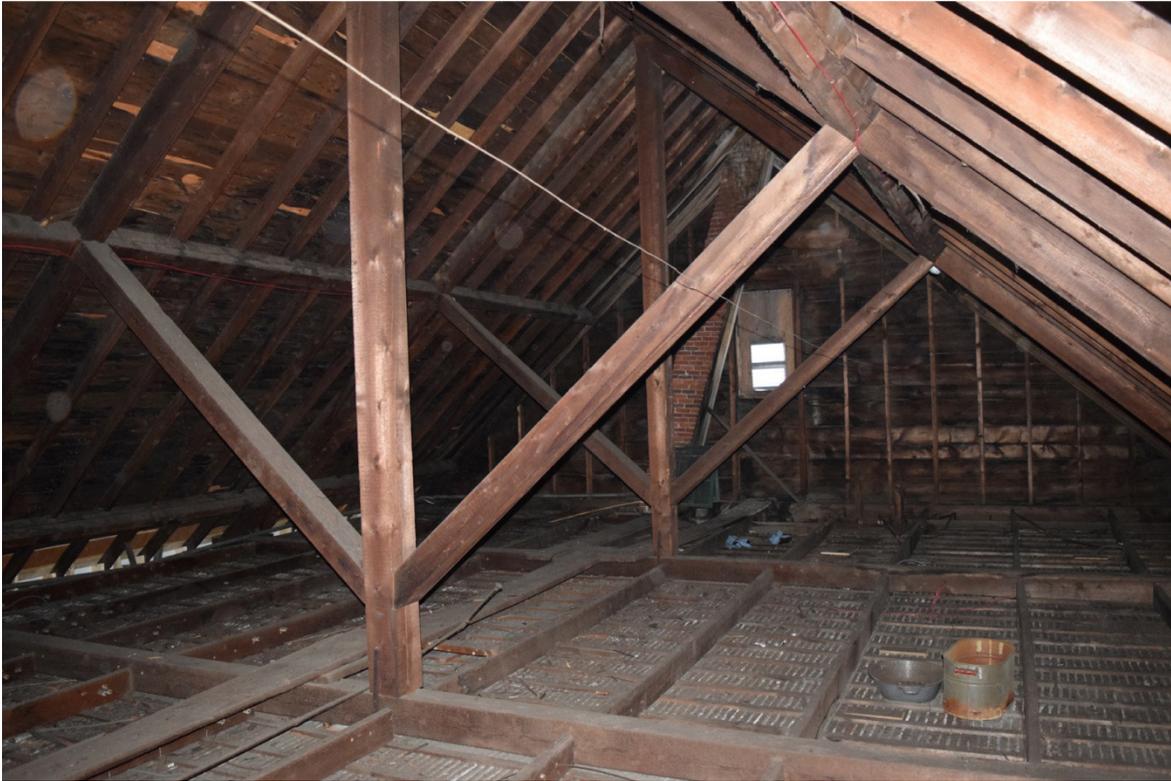
Attic with kingpost trusses

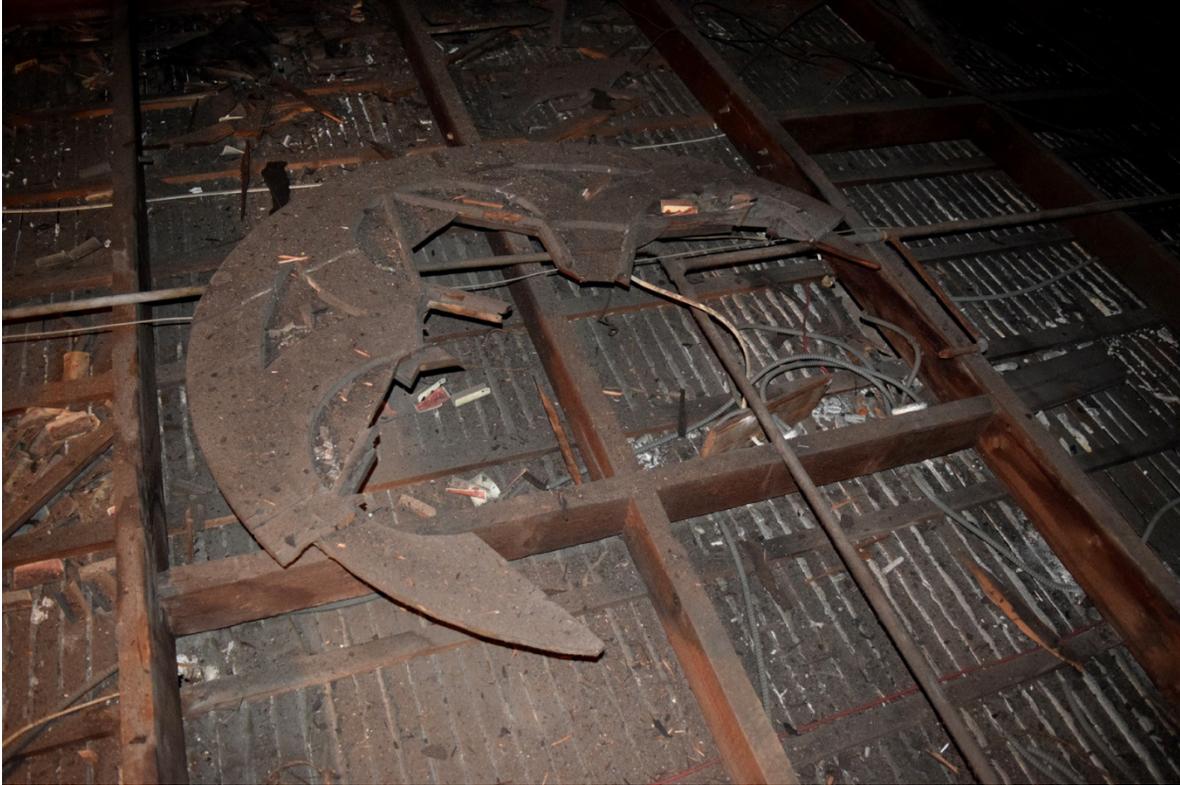
Attic- fragments of round window from front façade

5. Replacement of the vinyl windows in the bay with 2 over 1 wood windows to replicate the originals.
6. Reconstruction of the rose window and the trim around it. Pieces of the sash were stored in the attic, and an accurate reconstruction using these parts should be feasible.

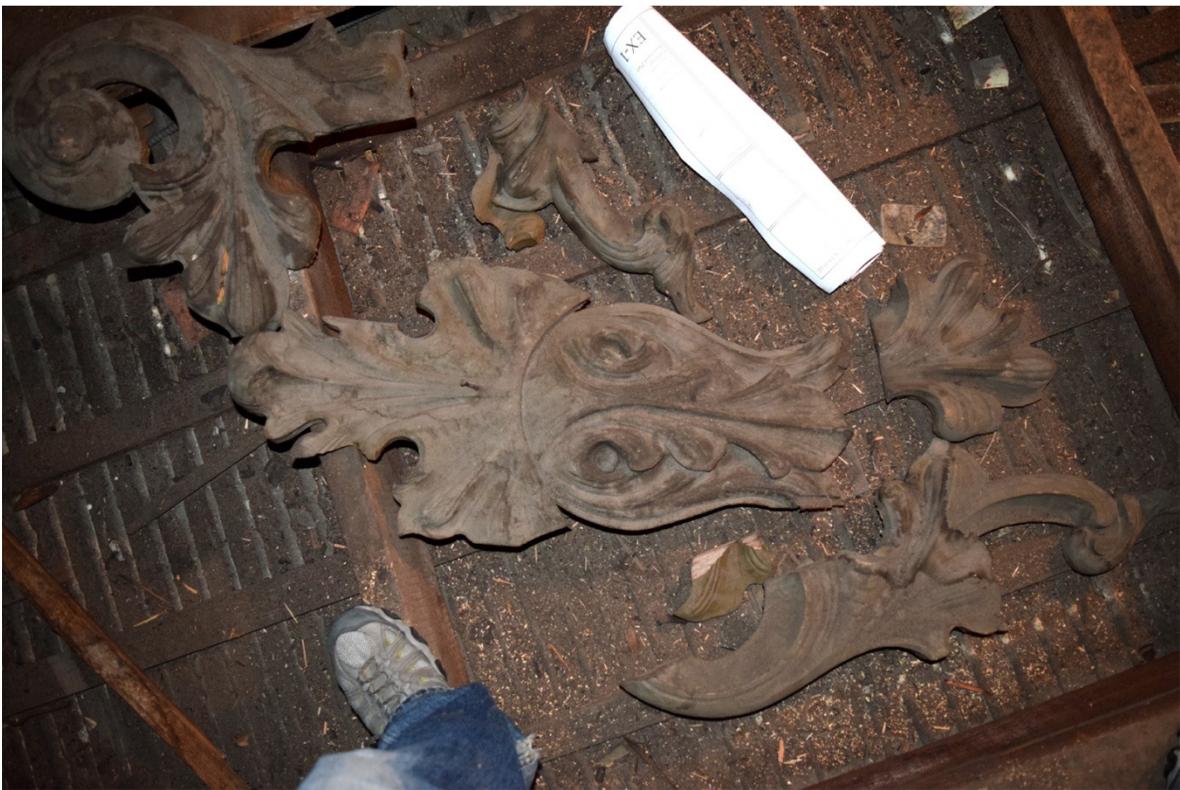
Attic- salvaged scrollwork from original entrance

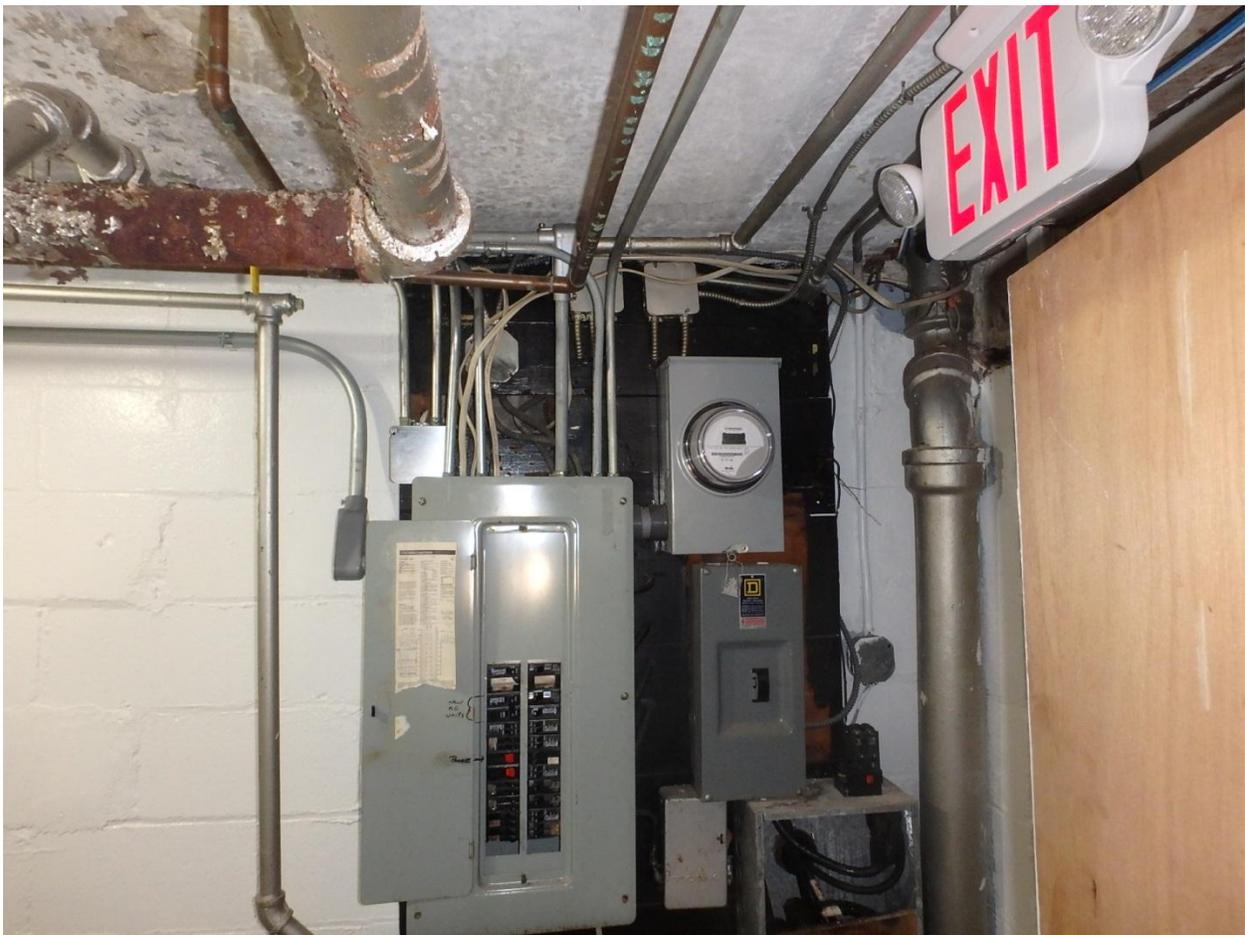
P9300002 – Electric Service

The existing electrical system is a 200 amp, grounded, 120/240 volt, single phase system. There is one 24 pole electrical panel located in the basement at the service entrance location. The electrical systems are in adequate condition given the buildings current use as a temporary office facility for the Beverly Building Department.

A building upgrade should include a new, larger electrical service, preferably three phase, to support a fully air conditioned building. We estimate the new service size to be 200A, 3 phase, 4 wire, 120/208 volt. The existing panel location appears to be adequate, but a second panel located in upper second floor is also recommended. New electrical room requirements are approximately 5 x 8 feet to serve electrical and telephone equipment.

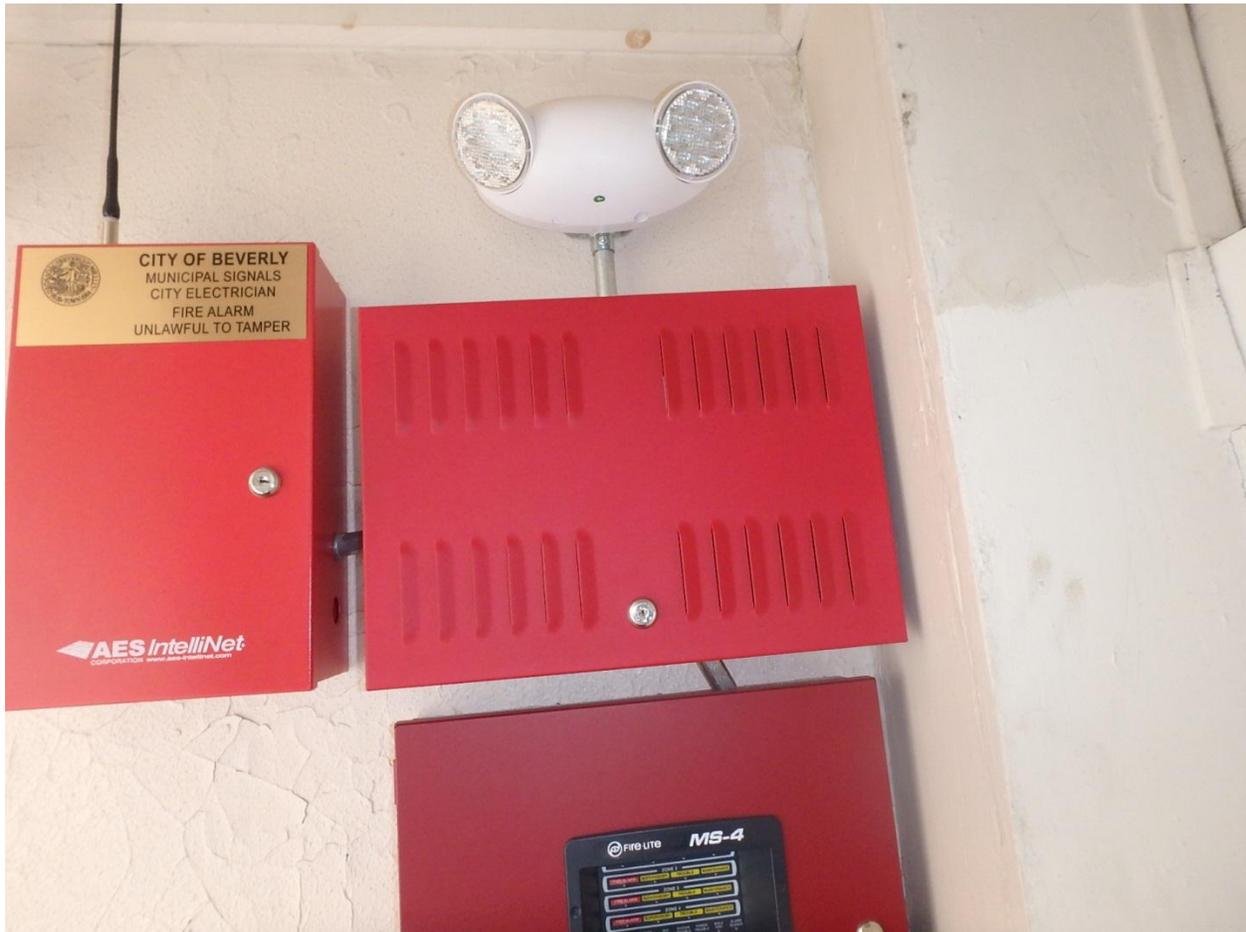
P9300006 – Fire Alarm Panel

Smoke detectors are located throughout the building as are notification appliances. These are in good condition, however, pull stations are older and should be replaced if failures are noted during routine testing.

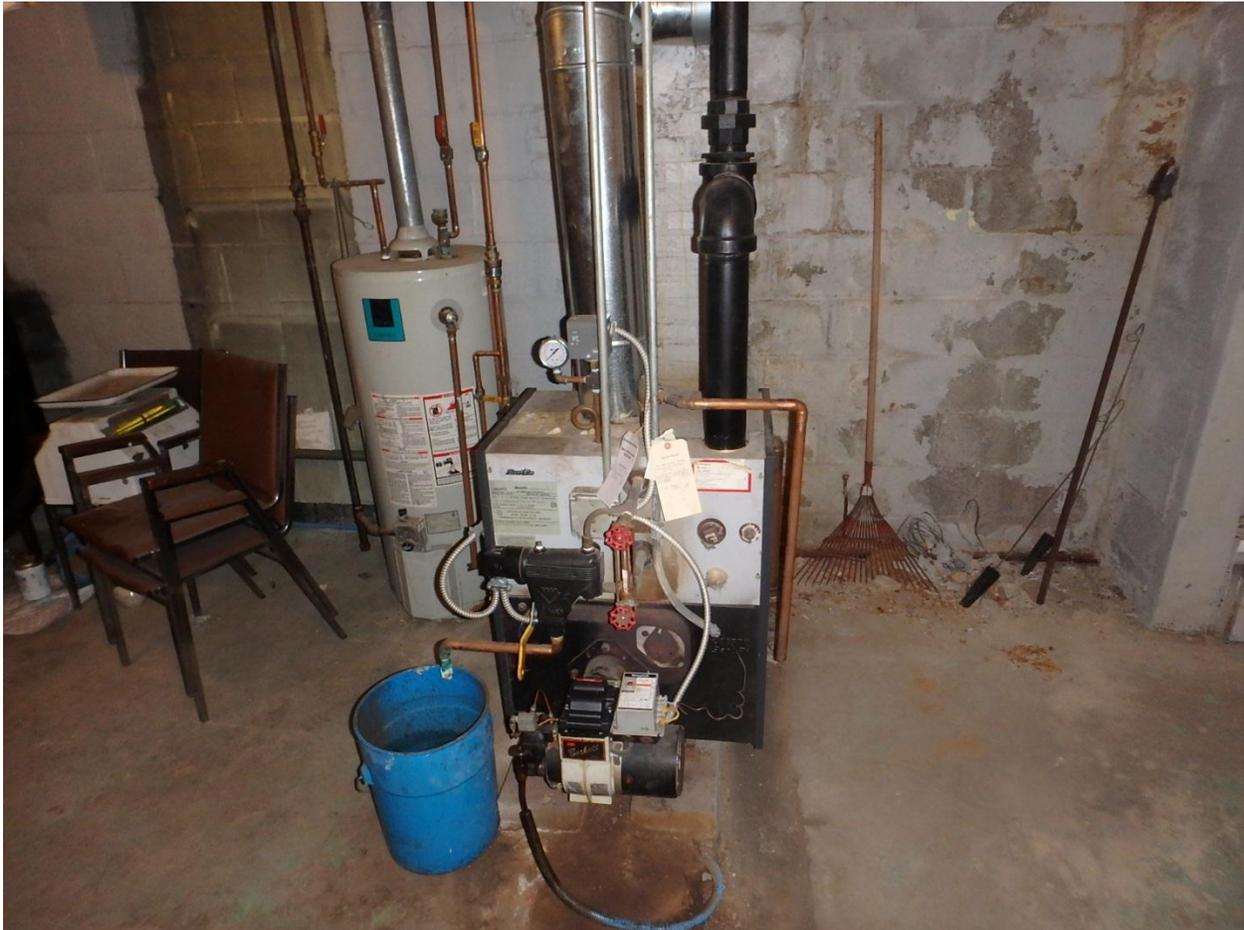
P9300016 – Oil Fired Cast Iron Boiler

The mechanical and electrical systems present a more complex picture. The heating system for the building is essentially the original steam system with a newer boiler and some more modern radiation. Two split system air conditioning units cool the main first floor space. The existing plumbing system is essentially obsolete, primarily due to accessibility issues posed by the existing space plan. There is no fire protection (sprinkler) system in the building. The electrical and fire alarm systems are adequate for the present uses, but they would need to be brought up to code in a major renovation.

1. HVAC: Replace the existing boiler. New hot water perimeter radiation. New air handling units with hot and chilled water coils and exterior condensers for cooling, one per floor. Energy recovery unit
2. Plumbing: assess existing street connection; replace if necessary. New water conserving plumbing fixtures in new toilet rooms, with new supply and waste piping.
