BEVERLY MIDDLE SCHOOL

EXISTING CONDITIONS

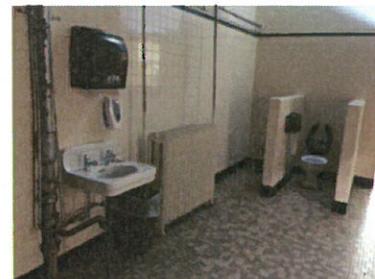
The kitchen area has a single interior grease interceptor which is reported to receive the flow from all the fixtures and drains in that space. The unit appears to have a capacity of approximately 50 gallons which is far too small for all the items connected to it.

The school had several toilet rooms upgraded with handicapped fixtures, approximately 10 to 15 years ago. All the other plumbing fixtures in the school are original from 1923. All the original fixtures are inefficient in water usage for flushing and hand washing and should be replaced. The newer handicapped fixtures meet current minimum standards, but still use more water than current LEED type fixtures.

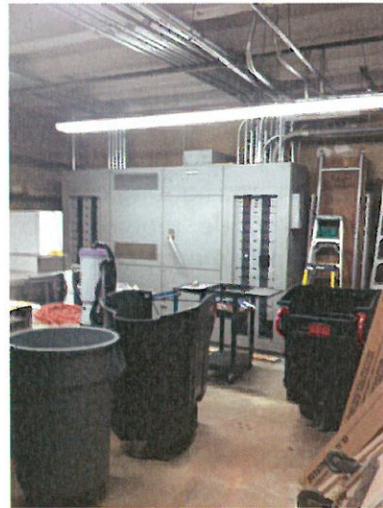
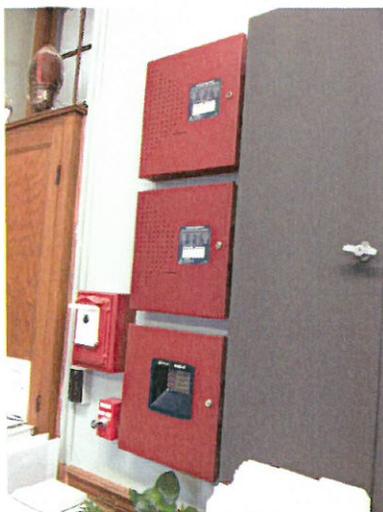
The 1600 amp pressure contact switch within the switchboard acts as the main disconnect switch for the building. The switchboard feeds panelboards throughout the building. The power distribution appears to be original to the building, is at the end of its life expectancy, and should be replaced with a new. The power distribution appears to be in poor condition.

The building does not have an emergency generator. Emergency lighting is provided by exit signs with battery back-up, emergency battery units with integral light heads, combination emergency battery units/exit signs, and remote emergency light heads. Deficiencies include no emergency lighting outside of egress doors, emergency lighting not working, insufficient emergency lighting coverage, and insufficient exit signage marking paths of egress. The emergency lighting appears to be in poor condition.

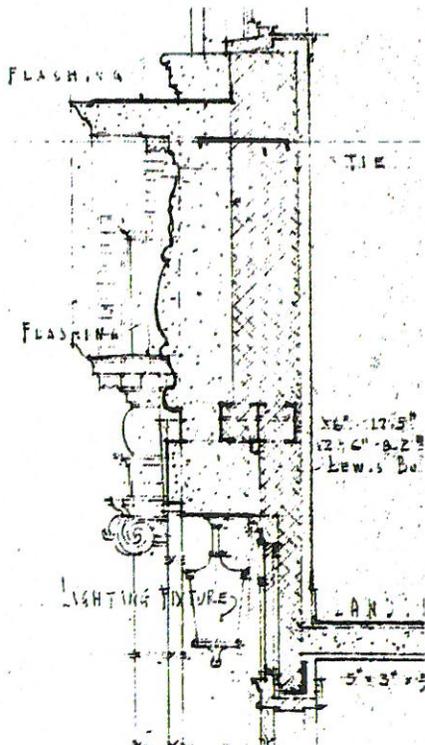
The Massachusetts State Building Code (780 CMR) has been updated and amended a number of times since the construction of the building. The State Board of Building Regulations and Standards regularly updates and amends its regulations. Based on these regulations, we found the following items to be in non-compliance:

- Occupied spaces (classrooms and offices) currently provide an entrance from within an egress stairway.
- Egress stairway enclosures, including door assemblies, require a minimum two-hour fire separation assembly.
- Boiler room does not have a one-hour rated fire separation assembly due to size of room and boilers.
- Two means of egress from spaces having an occupant load of greater than 50.
- Fire extinguishers.
- Fire separation assembly between Use Group E (Educational) and Use Group A-3 (Assembly – Cafeteria, Gymnasium, Auditorium) (one-hour fire separation required).
- Handrail and guardrail at egress stairways.
- Wood floor structure not allowed in building of this type and size.
- No sprinkler system.

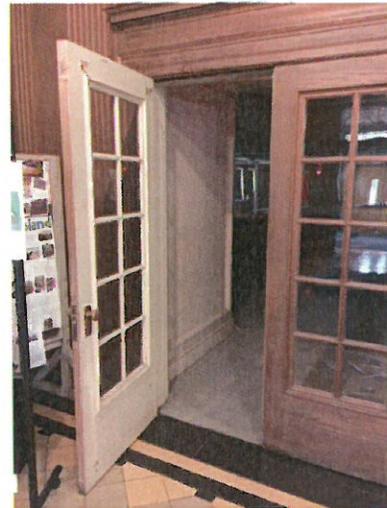
Based on these regulations, we found the following items to be in non-compliance or not accessible to the disabled:

- Doors leading to rooms in the school including classrooms, Auditorium, Gymnasium, Library, Administration, etc. Non-conforming knob-type hardware currently exist. Lever handles are required.
- The main public entrance to the building is not accessible.
- Exterior egress doors not accessible.
- All entries into classrooms require clear floor space adjacent to latch side of the door for entry and exit.
- Check-in counter at Administration Office.
- Lack of proper interior building signage (braille).
- Toilet rooms.
- Water fountains.
- Access to stage from the main floor within the Auditorium.
- Wheelchair and companion seating in the Auditorium.
- Library Circulation Desk.
- Accessible sink where provided.

- Ramps must be reconfigured for proper handicap slope and handrails.
- Floor level changes.
- All stairs (handrails and nosing).
- Alarms and strobes within classrooms.
