# FORM B – BUILDING

MASSACHUSETTS HISTORICAL COMMISSION  
MASSACHUSETTS ARCHIVES BUILDING  
220 MORRISSEY BOULEVARD  
BOSTON, MASSACHUSETTS 02125

**Address:** 14 Summit Avenue

**Historic Name:** Beverly Poor House

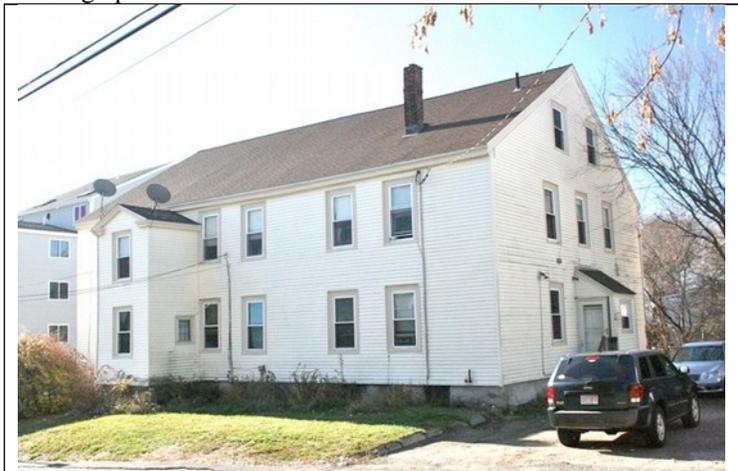
East (façade) and north elevations

The building consists of a rectangular block measuring 62 feet long by 48 feet deep, with a two-story pavilion set off-center on the east (façade) elevation and a smaller, one-story entrance vestibule centered on the north elevation. The building rises 2 ½ stories from a parged brick foundation to a low-pitched, side gable roof without gable returns. Exterior walls are clad with vinyl siding and trim. Windows are typically 1/1 replacement sash without trim; 8/8 sash survive at the basement level on the south elevation. A small, slender chimney rises from the front slope of the northern end of the building.

The long, asymmetrical east façade contains six window bays, including a substantial, nine feet wide by seven feet deep pavilion in the penultimate bay at the southern end. The pavilion rises two stories from a parged granite foundation to a shallow front gable roof with gable returns. Its east façade has one window centered on each story; its north elevation contains a small 9-pane window offset on the first floor.

The symmetrical north elevation contains three bays in the middle of the first and second floors, including a small entrance vestibule with a shed roof and single-leaf door facing the street, and two windows in the half story. The south elevation has five symmetrical bays on the first and second stories and two windows in the half story. A single-leaf door without ornament is centered on the first floor of this elevation, accessed by a utilitarian, modern wood stairway and deck. The fully exposed basement on the south elevation features a utilitarian, single-leaf door in the center, flanked by one 8/8 window to its west and two 8/8 windows to its east.

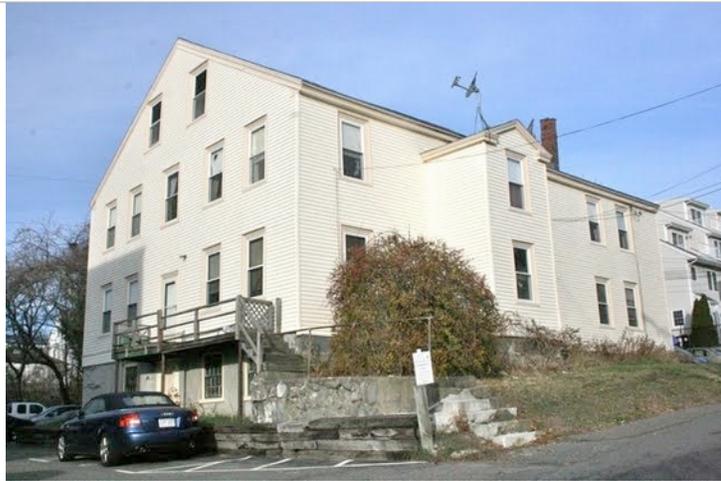
South and east (façade) elevations

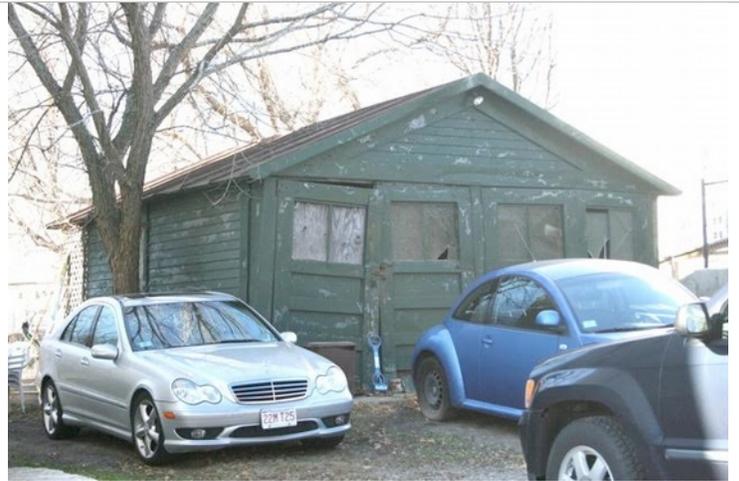
Garage

The garage, set in the center of the northern end of the property, is wood frame construction, rising one story to a gable-front roof with standing seam metal roofing and no gable returns. Sheathed in metal fashioned to look like wood clapboards, the garage's east (façade) elevation is occupied by two pairs of hinged wood doors, each having a column of three horizontal wood panels surmounted by a pair of glass panes. The north and south side elevations each contain a single roughly centered window; they appear to be filled in with plywood.
