GAR Hall
Beverly, MA

**Building Assessment,
Preservation and Reuse Plan**

GAR Hall
Building Assessment, Preservation Plan and Reuse Plan Study
15 January 2017

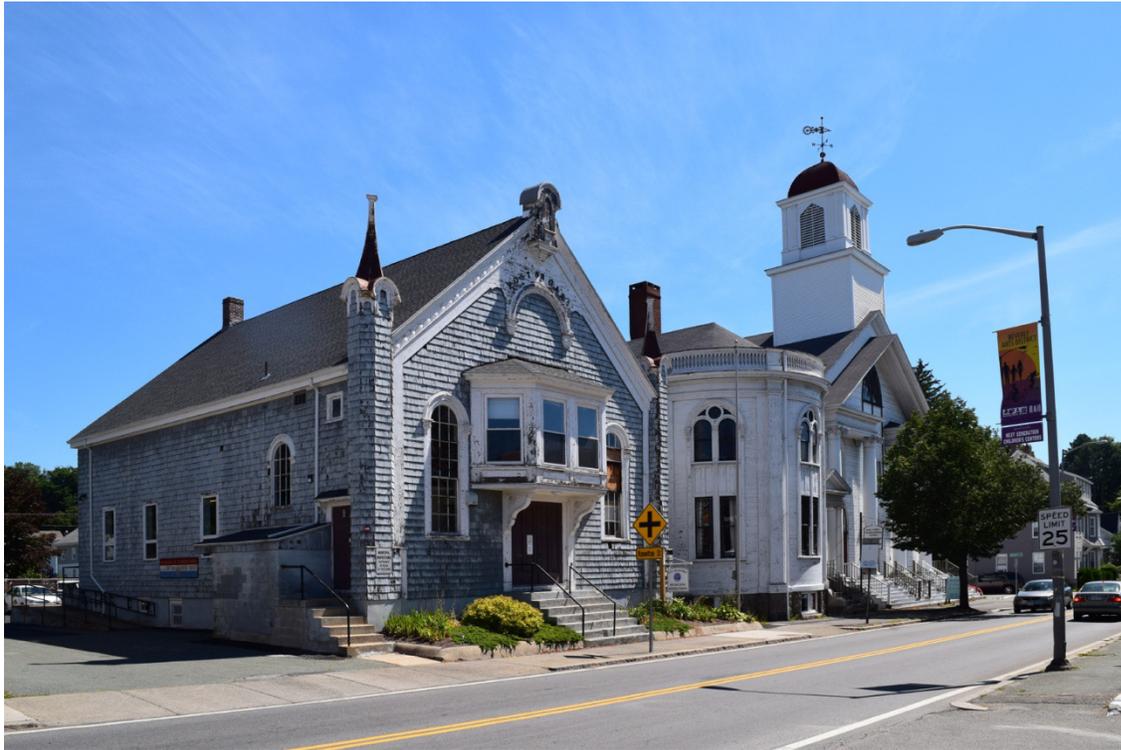
View from Dane Street SW

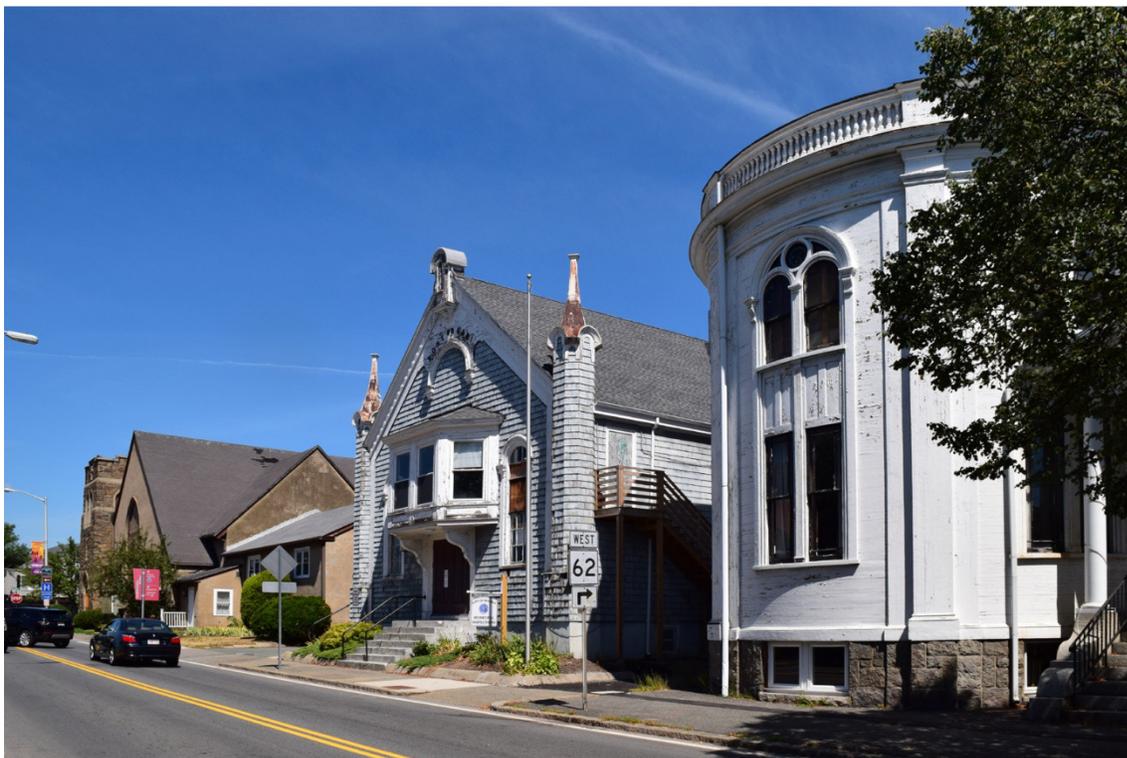
View from Dane Street SE

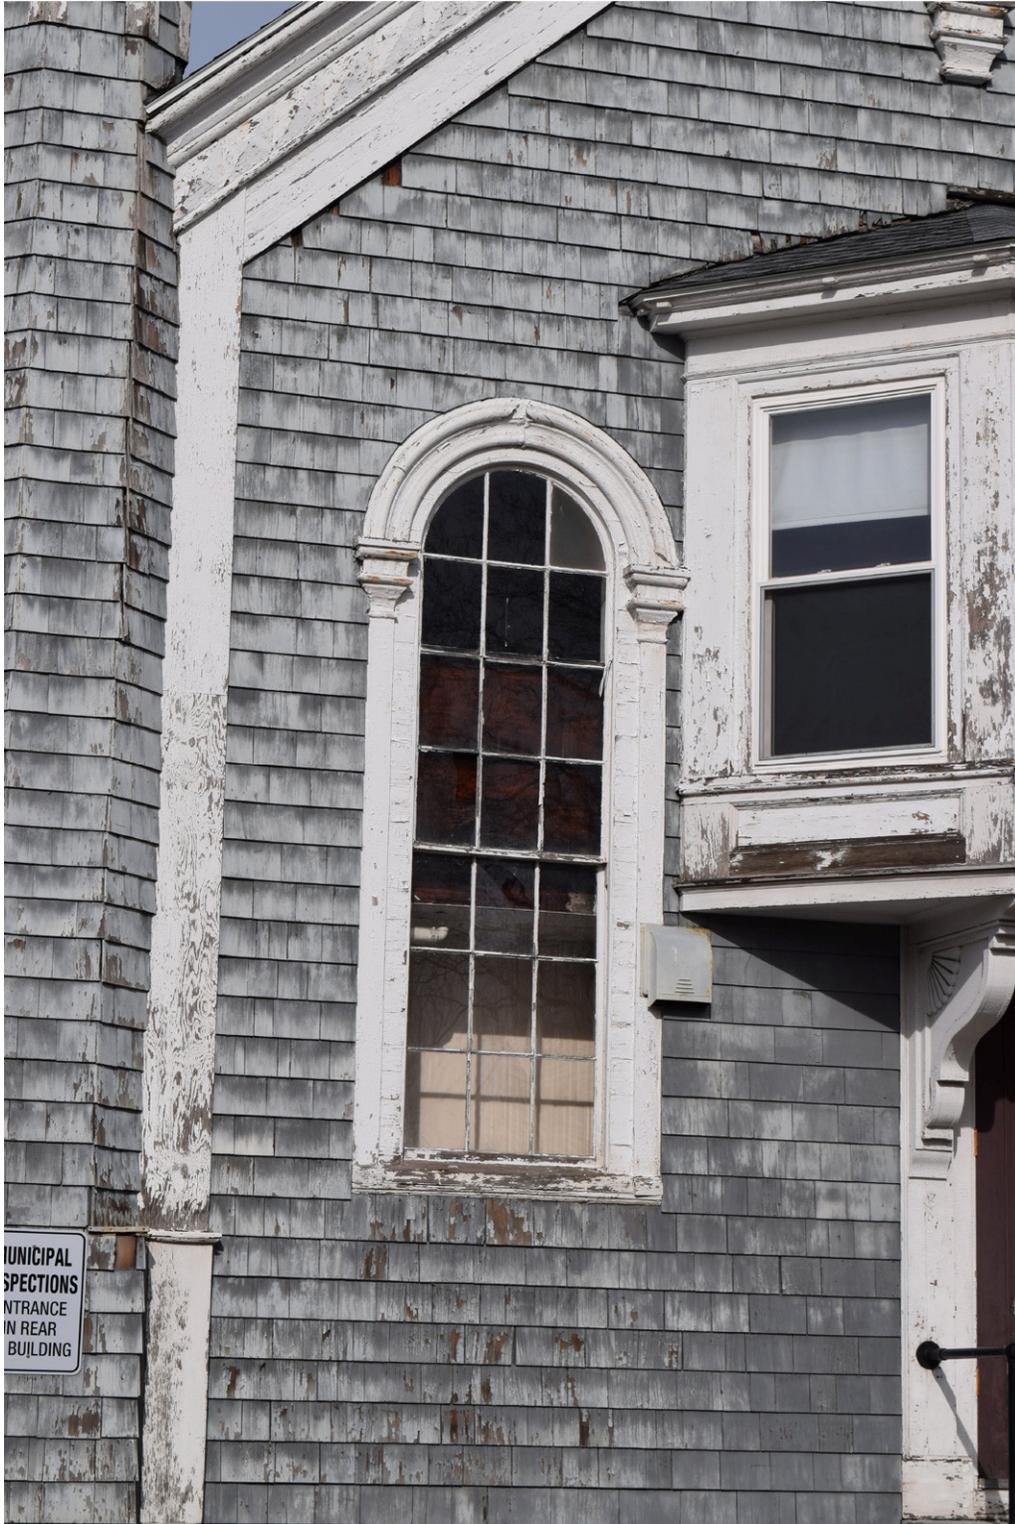
- The front entrance doors remain, but the transom panels were altered for the projecting bay in 1905-7.
- The original double hung windows remain on the front facade. They are in poor condition but should be evaluated for restoration, and they could serve as a model for the replication of windows on the sides of the building.

- The block at the roof peak remains, but it is in need of repair and restoration.
- The rake trim detail remains, including the arch at the center.
- The rose window and the adjacent trim are missing.

- The shingle siding is rather rustic in the context of the Romanesque character of the original design. It is also deteriorating, especially on the front façade, which exacerbates the contrast.

Front façade detail

1. Removal of the present wood shingles and examining the substrate, making repairs where required.
2. The 1905 siding was wood clapboards applied over the original flush wood siding. This should be reconstructed, with a water table at the base as can be seen in the historic photograph.

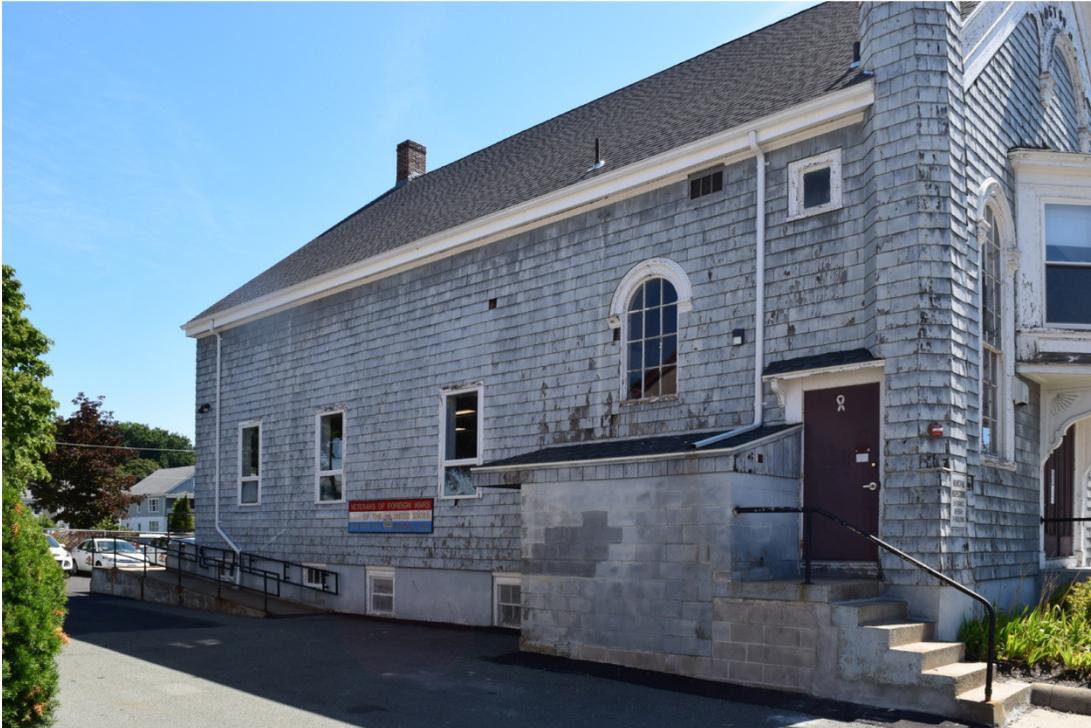
Side elevation at driveway

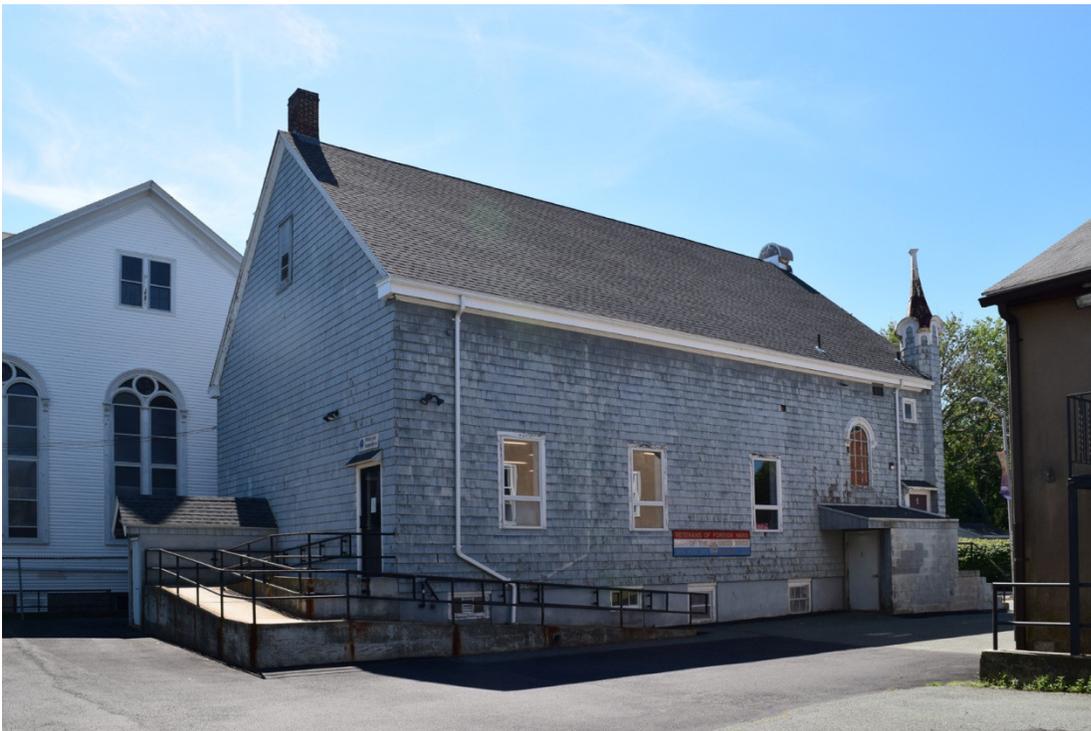
Side elevation and existing ramp

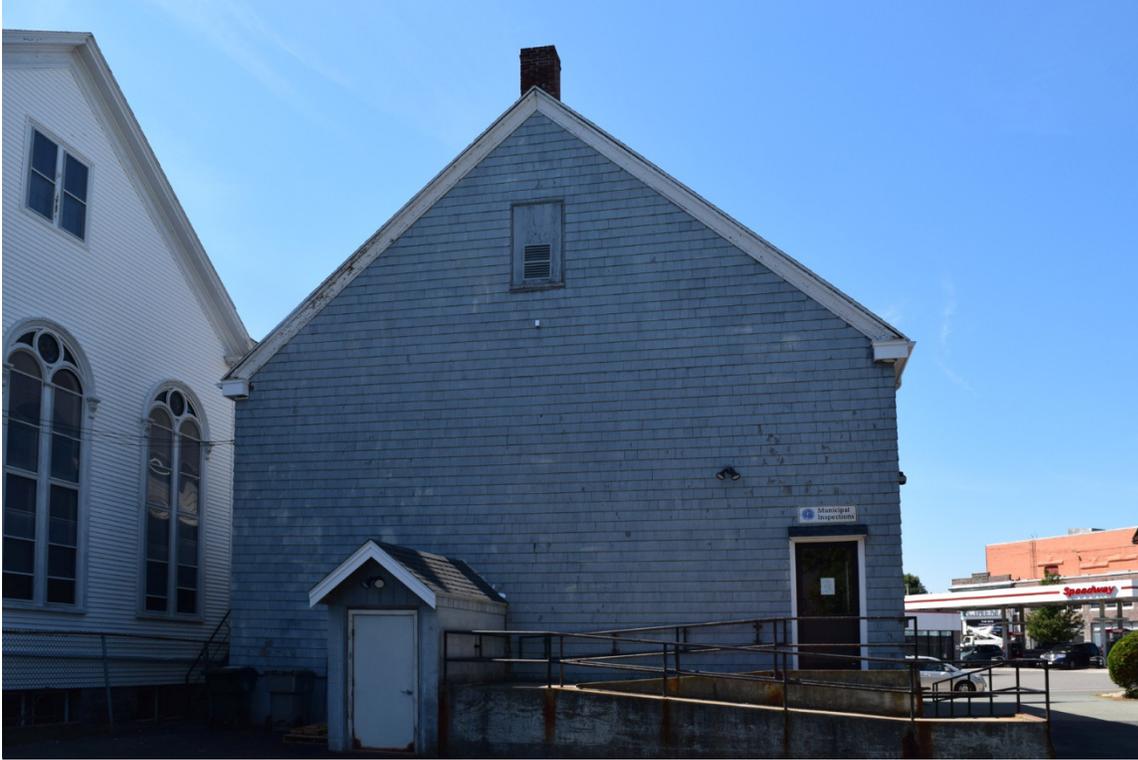
Rear elevation and ramp

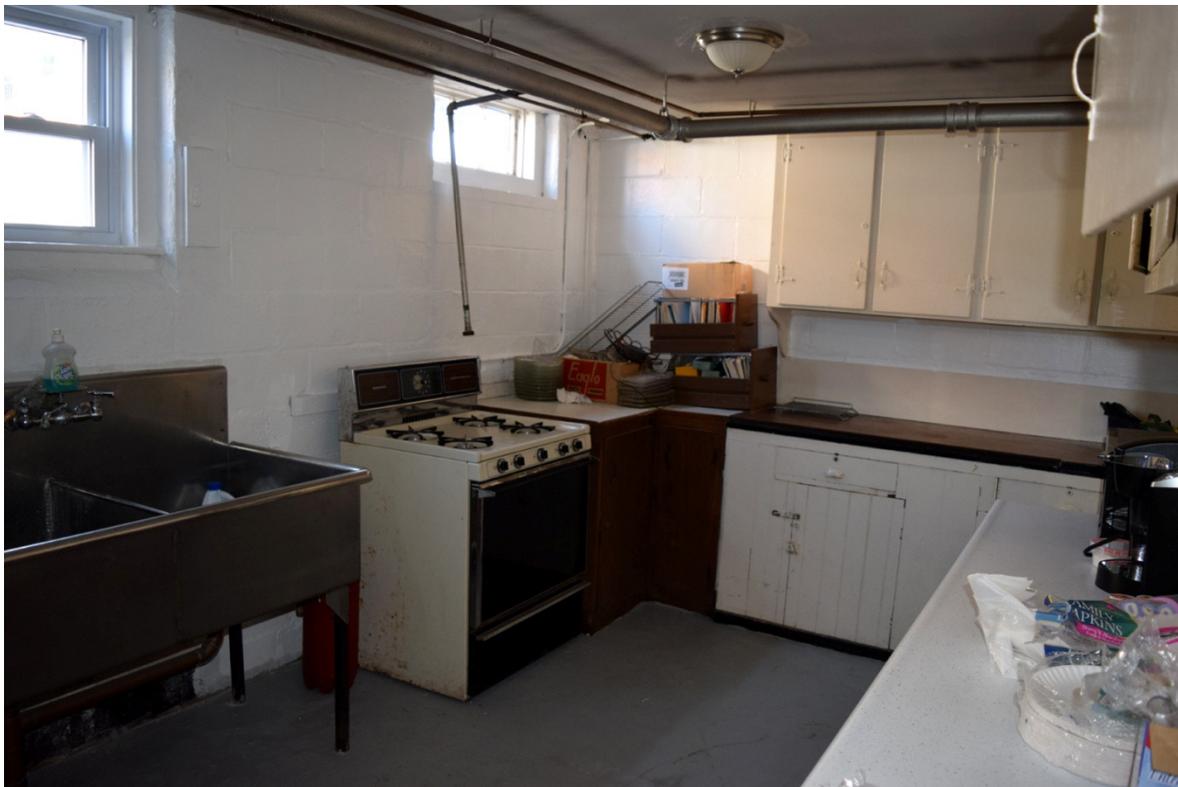
Existing kitchen in basement

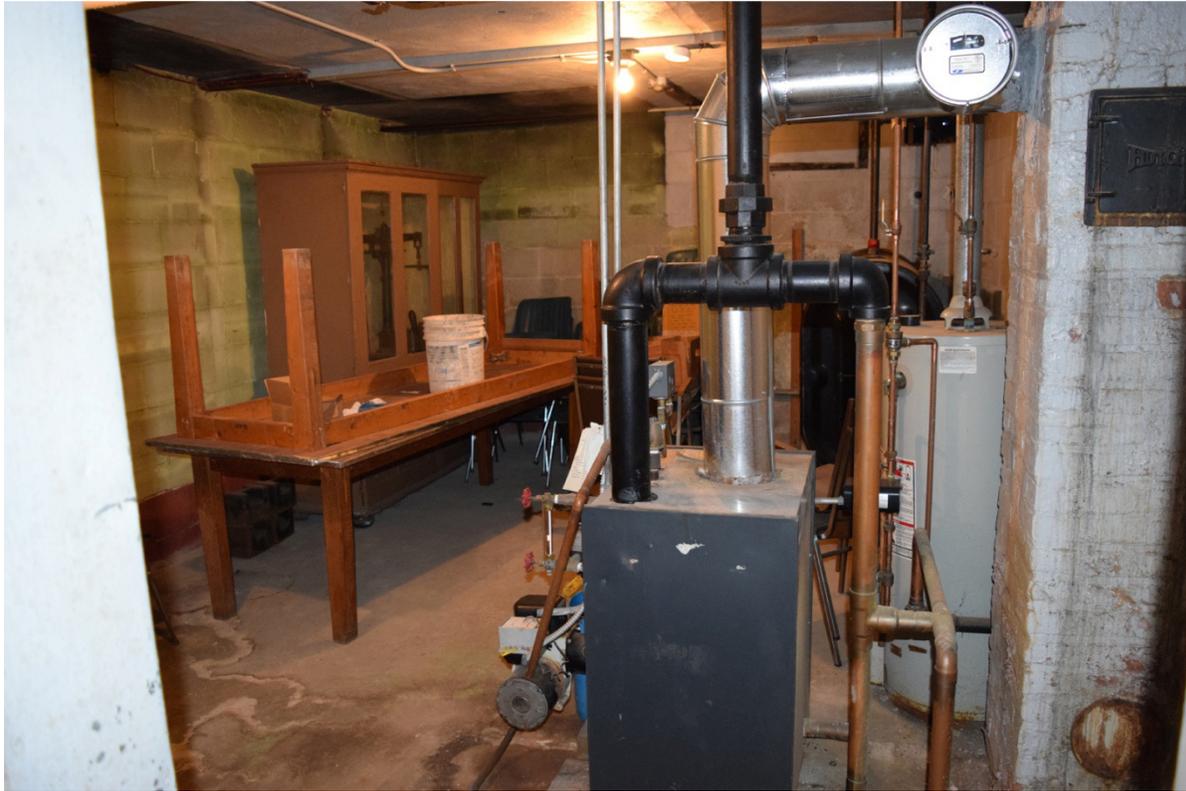
Boiler room

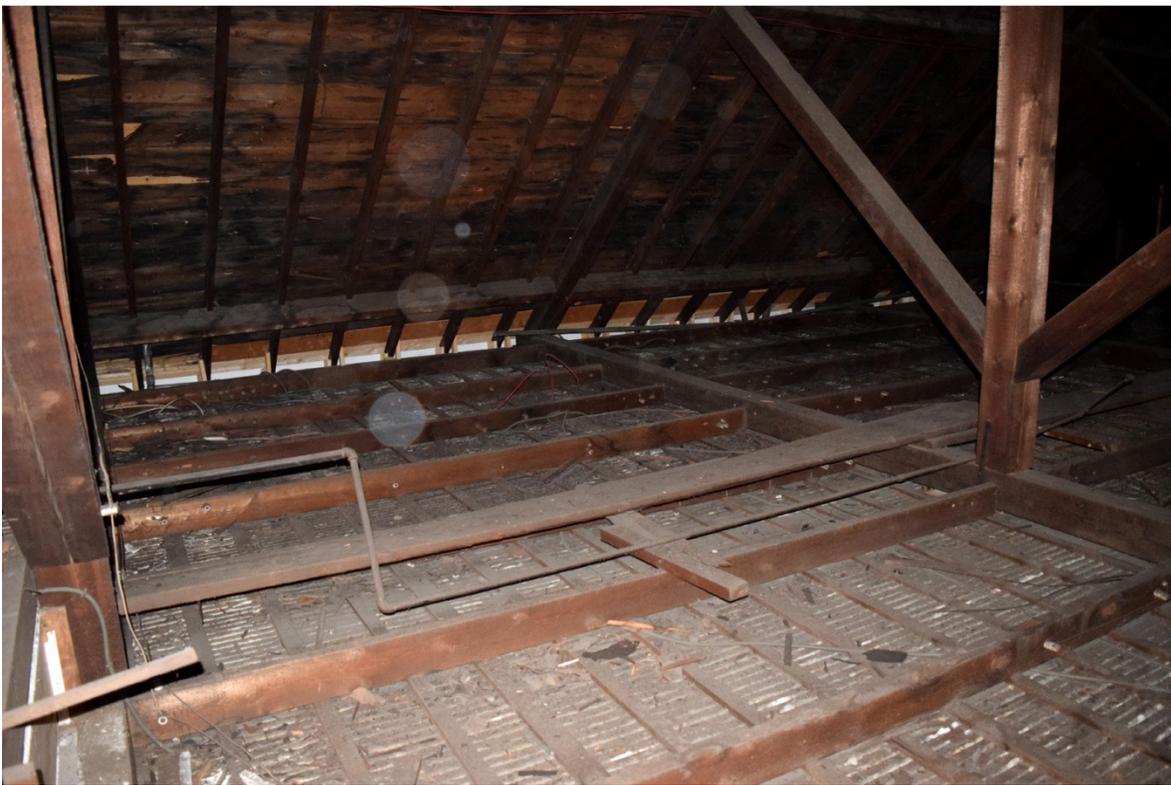
Attic- framing for plaster ceiling

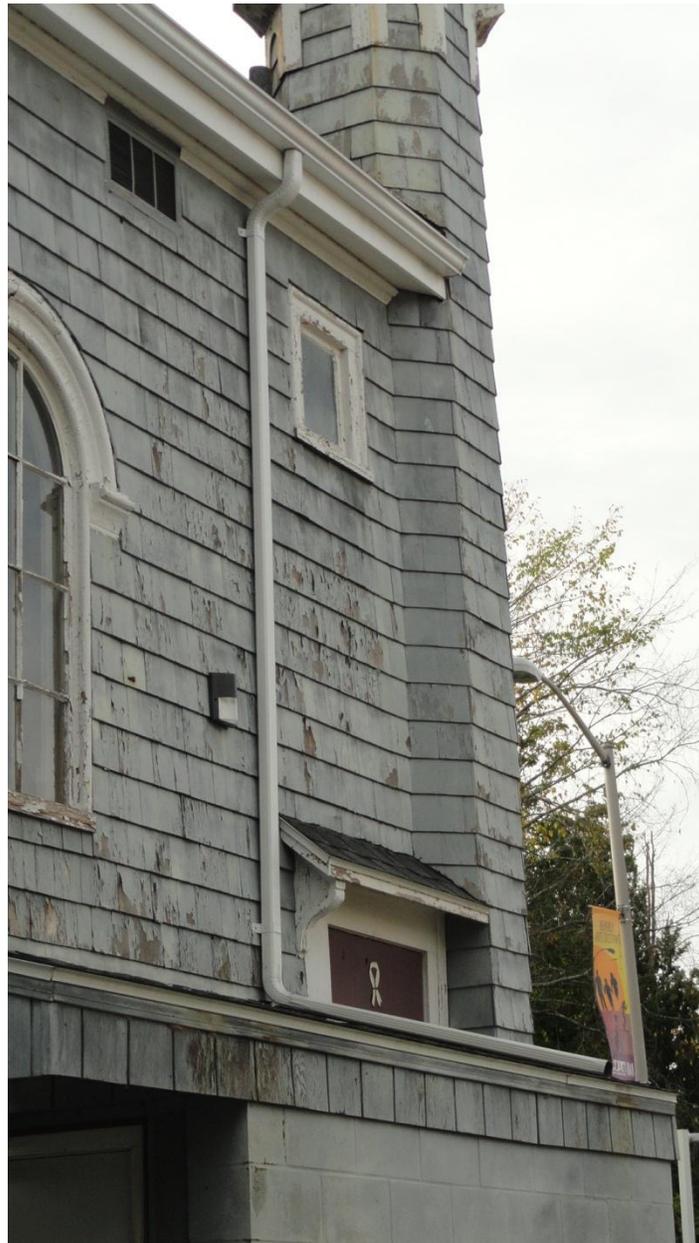
Downspout over low roof

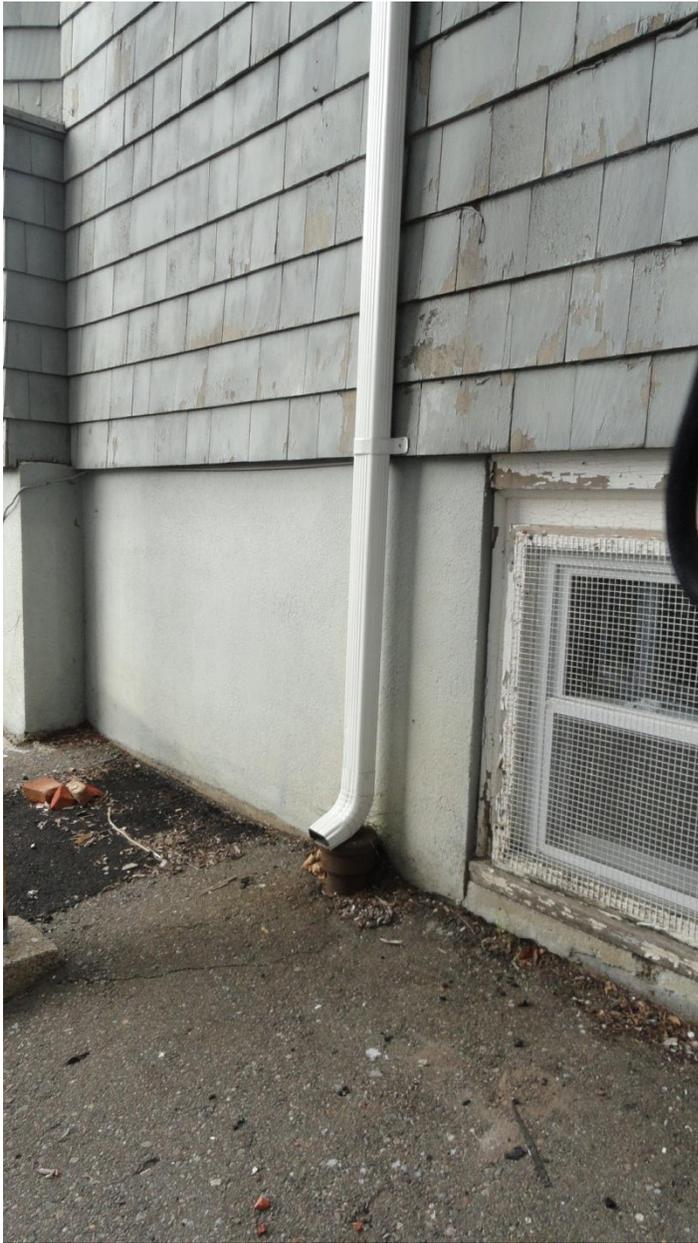
Downspout to grade
